MEMORANDUM

Project: 090557-01

Re: Revised Post-TCRA Semi-Annual Inspection Report - July 2014 Inspection

This document reports the results of the July 2014 inspection of the armored cap cover, fencing, and signage installed for the Time Critical Removal Action (TCRA) at the San Jacinto River Waste Pits Superfund Site (TCRA Site). This document supersedes the Post-TCRA Semi-Annual Inspection Report - July 2014 Inspection, dated August 11, 2014.

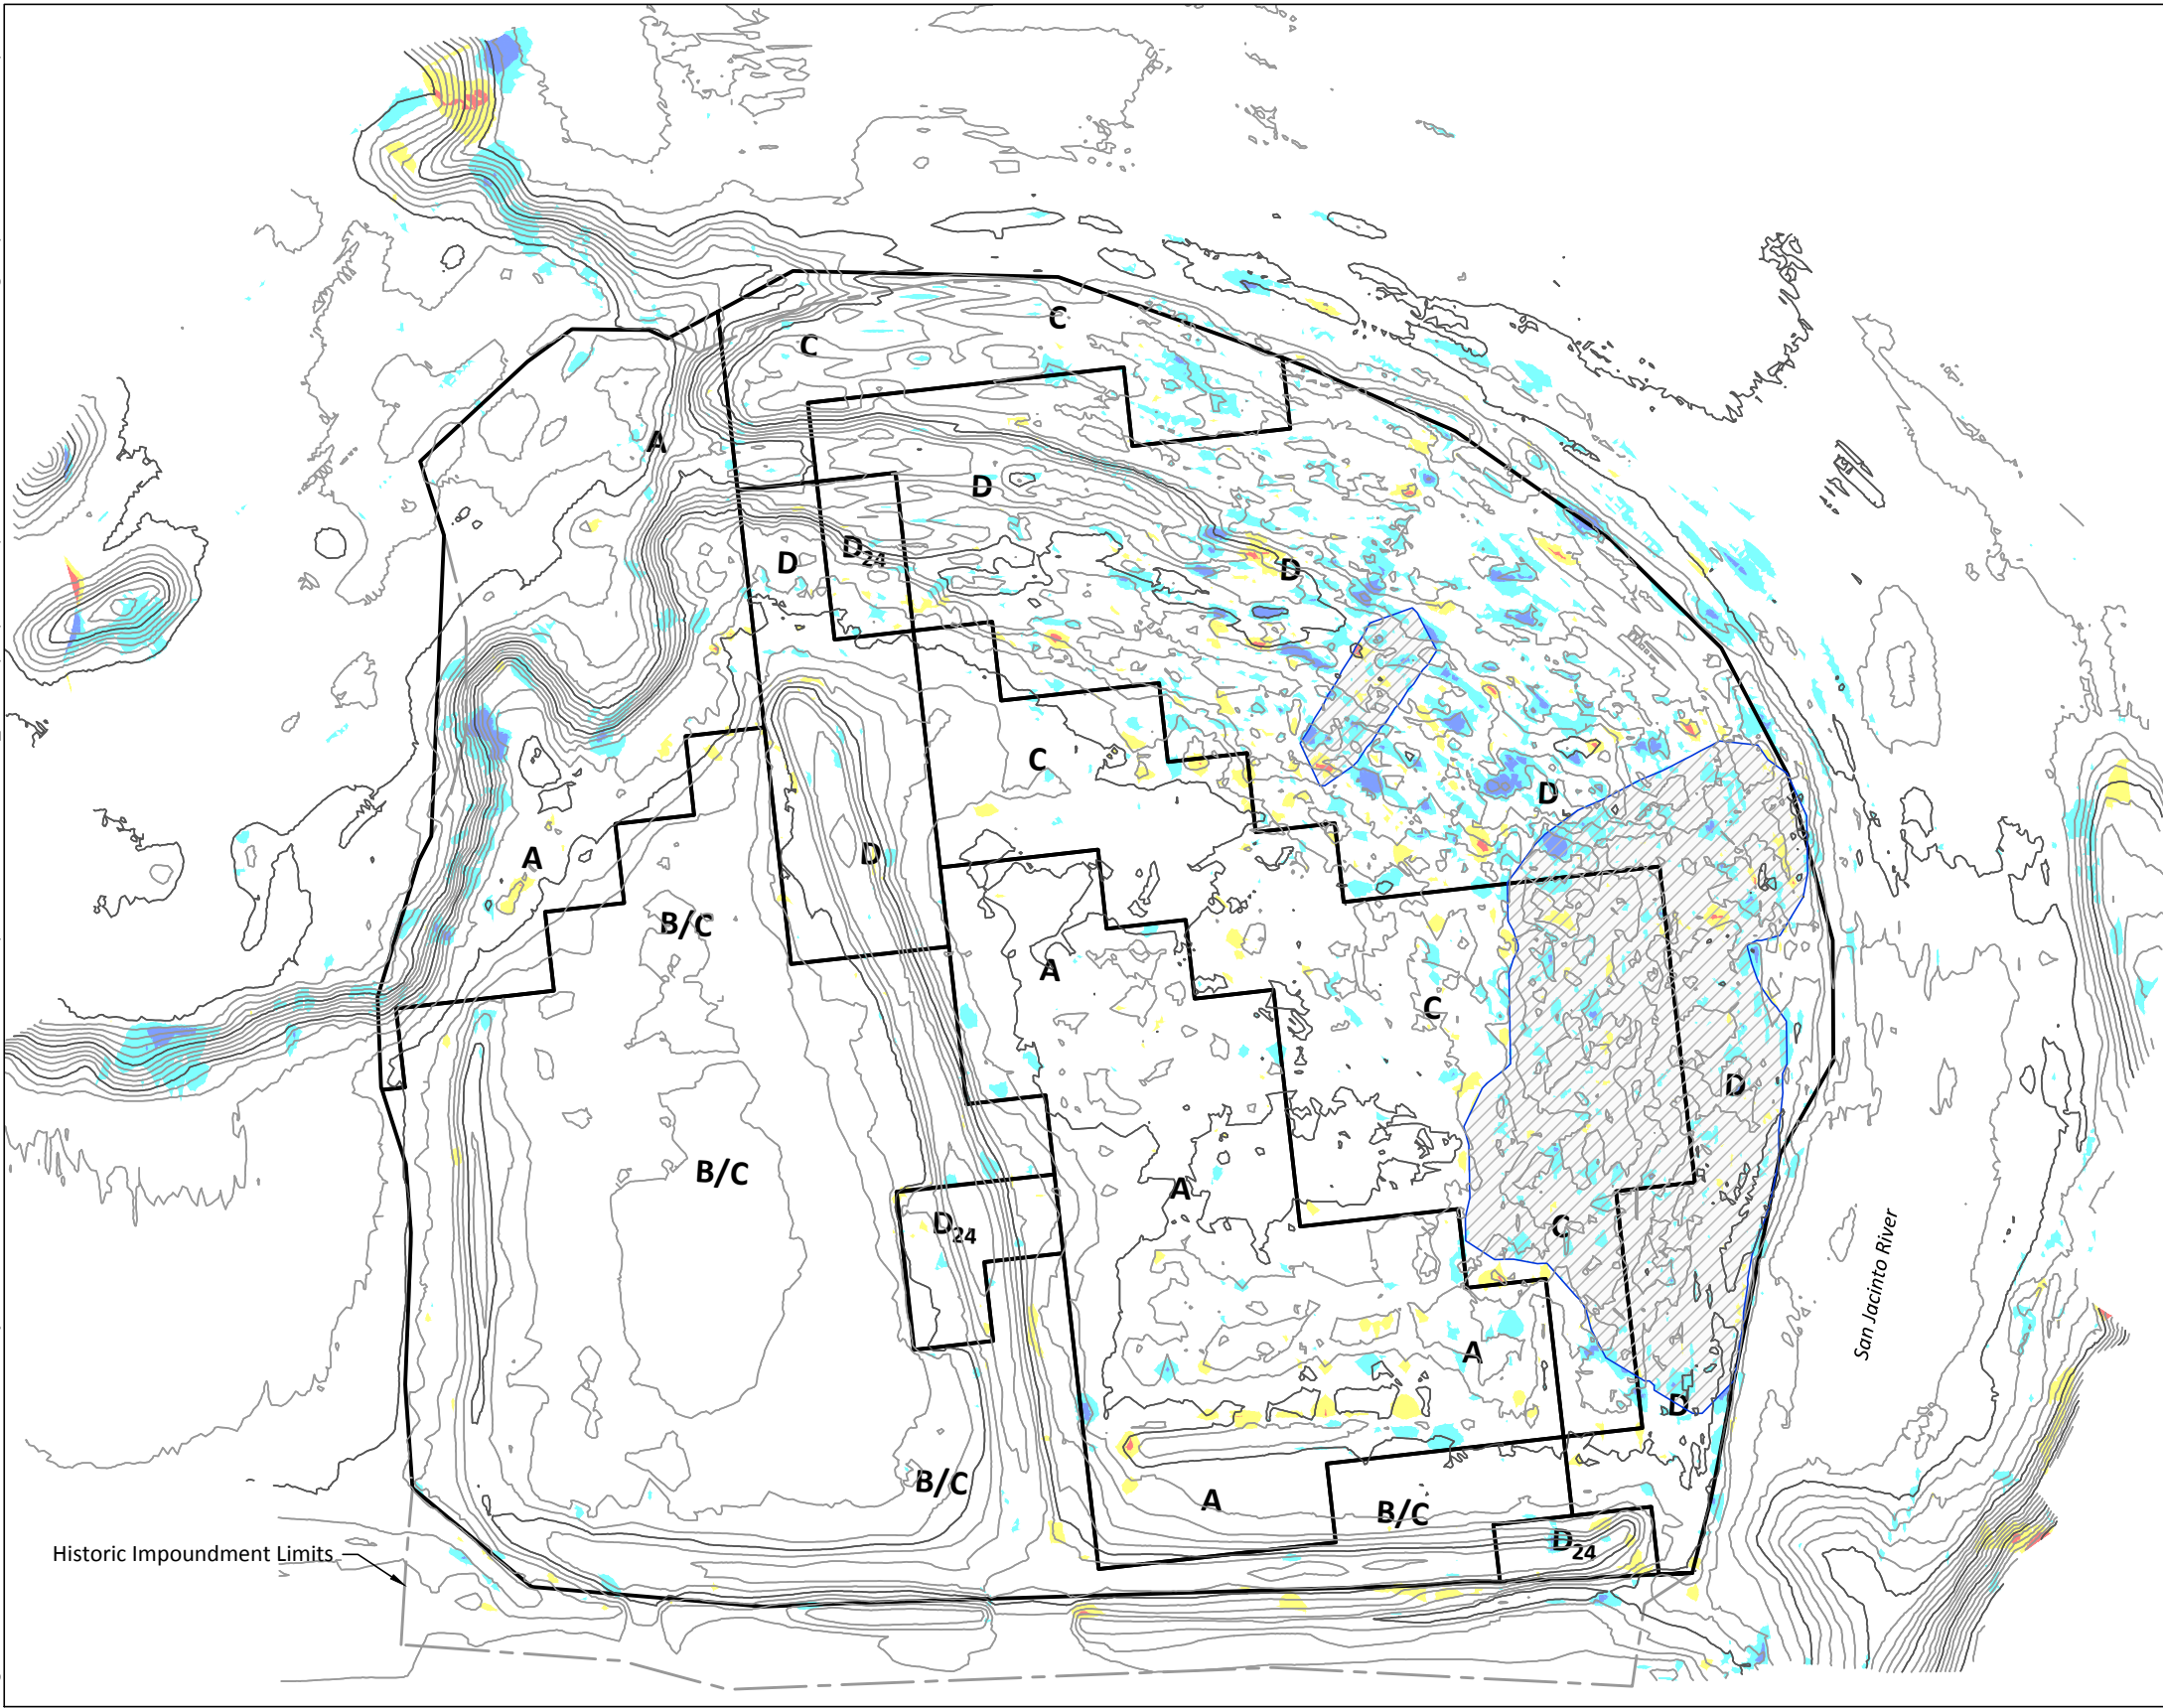
Figure 3 – July 2014 Semi-Annual Inspection Survey

The armored cap was enhanced by adding additional armor rock where slopes exceeded 3 horizontal/1 vertical, in January 2014 (Anchor QEA 2014). A survey was conducted in February 2014 following completion of the enhancement work. With the one caveat mentioned below, the survey data from July 2014 and February 2014 post-enhancement surveys were compared to evaluate the differences in the top of the armored cap elevation between surveys (Anchor QEA 2014). These differences are shaded and shown in Figure 3.

In February 2014, the hatched areas on Figure 3 could not be accessed by boat during the survey in February due to continued frontal systems causing low water conditions, and furthermore, in February 2014, the presence of organic growth within the hatched areas did not allow a wading survey to be conducted safely (Anchor QEA 2014). The July 2014 survey data within the hatched areas on Figure 3 were therefore compared to the most recent survey data for that area, from October 2013, to evaluate differences in the top of the armored cap elevation between those two surveys for those areas. The differences between the July 2014 and October 2013 survey data for the hatched areas are shaded and shown on Figure 3.

The survey results generally indicate continued sedimentation/deposition on the surface of the armored cap in submerged areas. The results do not indicate any loss of cap material.

The OMM Plan provides for manual probing of armored cap thickness to be performed in areas identified by the topographic or bathymetric surveys as more than 6 inches lower in elevation than during the prior survey over contiguous areas of 30 feet by 30 feet. When the July and February 2014, and October 2013 surveys were compared, the results indicated that there were no areas that met the manual probing requirement. Therefore, no probing was conducted as part of the July 2014 inspection.

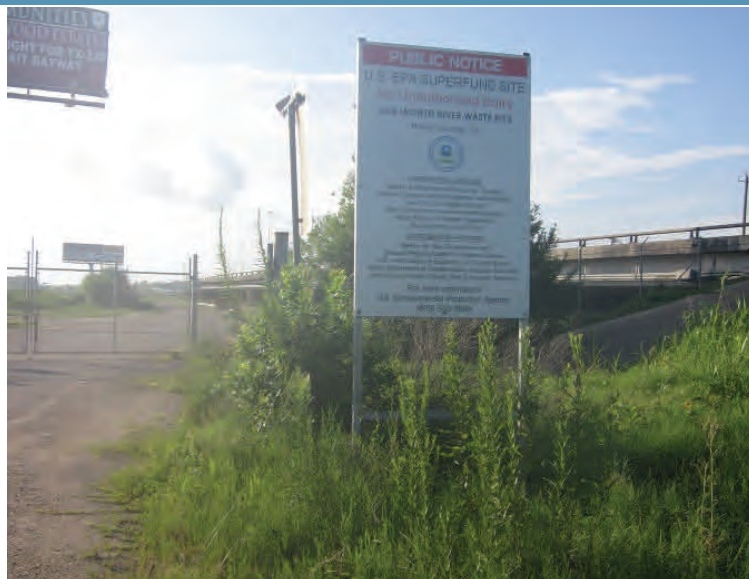
Three USEPA Public Notice signs are present around the TCRA Site located: 1) near the gate entry point for the perimeter fence north of I-10; 2) near a gate entry point south of I-10; and 3) at the end of the TxDOT right-of-way north of I-10 near the San Jacinto River (see Photographs 1 and 15 in Appendix A). These three signs were observed to be in place and undamaged.

Photograph 01: USEPA public notice sign located outside the access gate north of I-10 (view southeast)

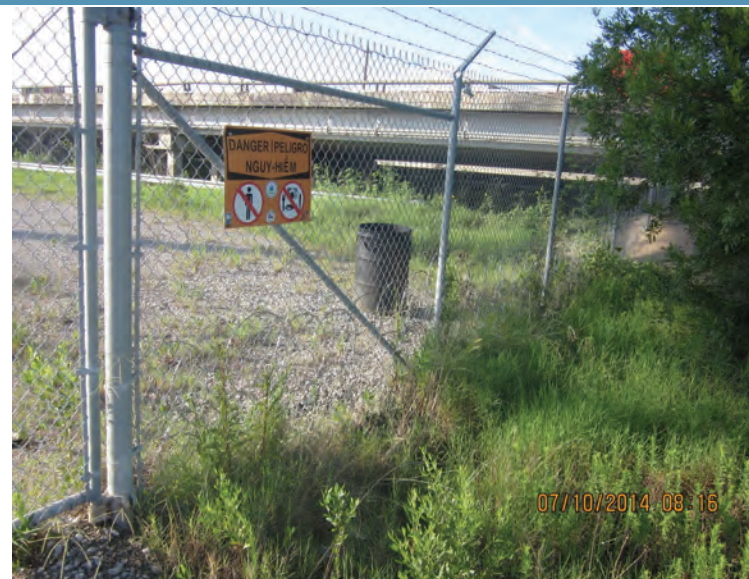
A breach in the perimeter fencing had been observed on June 17, 2014, north of and adjacent to I-10 on the west bank of the San Jacinto River. Repairs were made on June 20, 2014, by reattaching the chain link fence to the fence post. Barbed wire was also added along the lower portion of the perimeter fencing between the access gate and I-10 (see Photographs 2 and 3).

Photograph 02: Perimeter fencing adjacent to access gate north of I-10 with recently added barbed wire along bottom portion (view southeast)

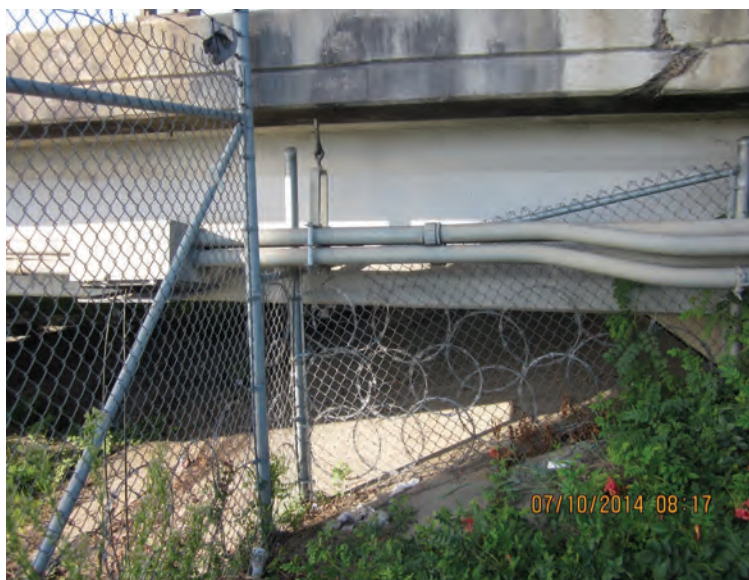
Photograph 03: Repaired fencing north of and adjacent to I-10 (view south)

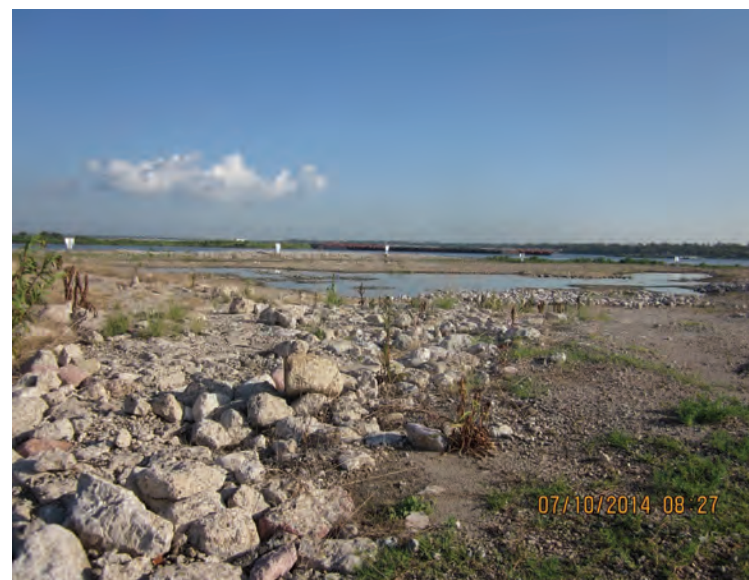
Photographs of the armored cap from the inspection event are provided in Appendix A (see Photographs 4 through 11). All of the visible portions of the armored cap were observed to be intact, and no movement or erosion of waste materials into the San Jacinto River was observed at any location during the visual inspection.

Photograph 04: Interior of Western Cell (view northwest)

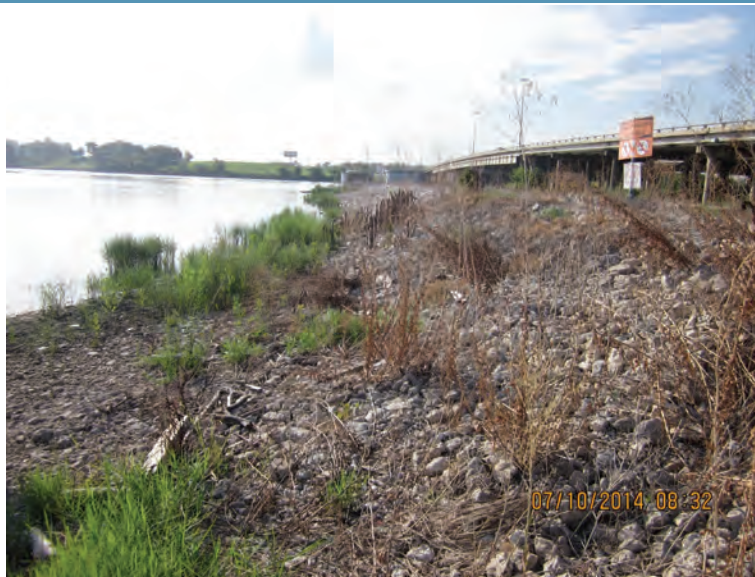
Grassy vegetation was observed around some intertidal areas of the Western Cell perimeter (see Photographs 5 through 6 and 8 through 10 in Appendix A). Following USEPA's notification and approval on May 28, 2014, vegetation was treated on July 15, 2014, using the vegetation control measures outlined in a letter to USEPA dated July 12, 2013 (Anchor QEA 2013).

Photograph 05: Vegetation and warning signs along southern berm (view east)

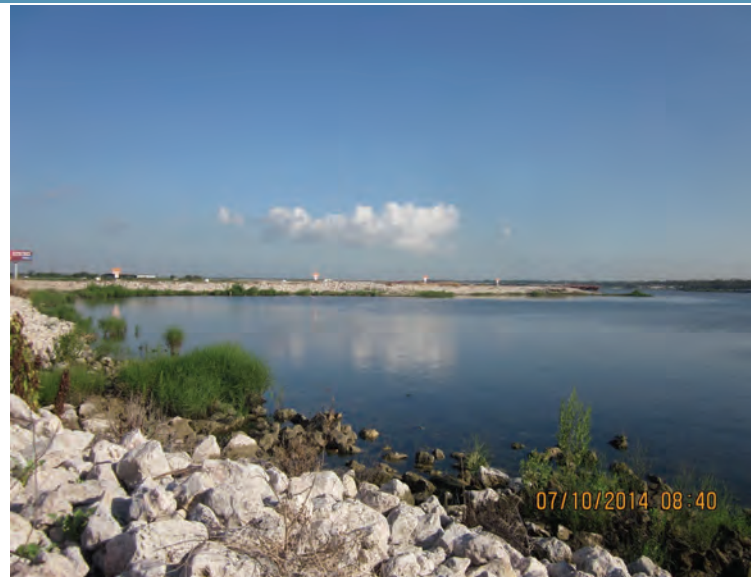
Photograph 06: Southern and central berms (view northwest)

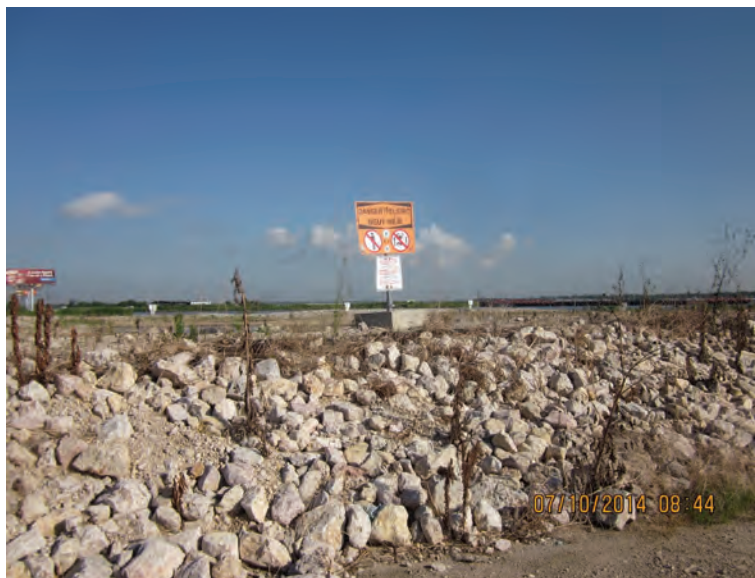
Photograph 07: Warning sign and dying vegetation along central berm (view west)

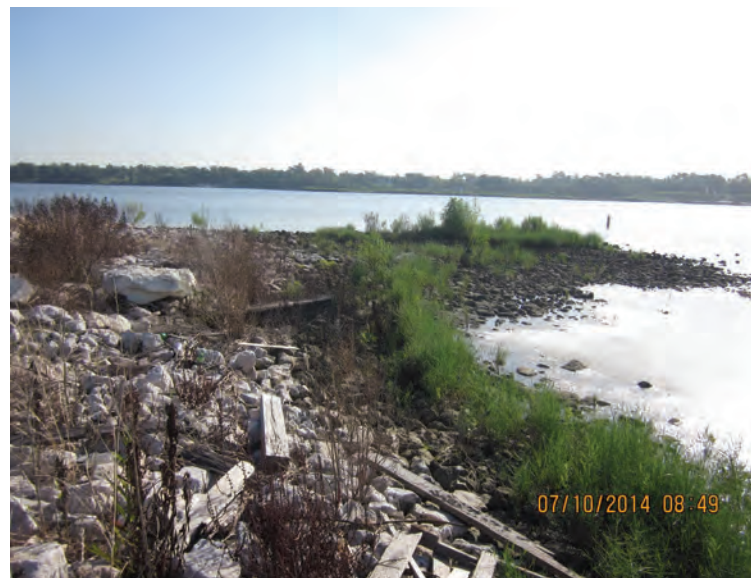
Photograph 08: Vegetation along northeastern end of central berm and warning buoy north of Eastern Cell (view northeast)

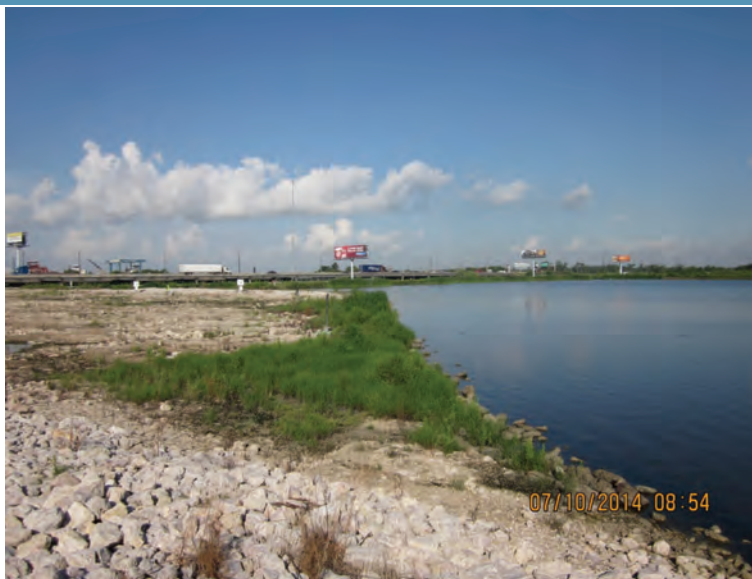
Photograph 09: Vegetation along northern edge of Western Cell (view southwest)

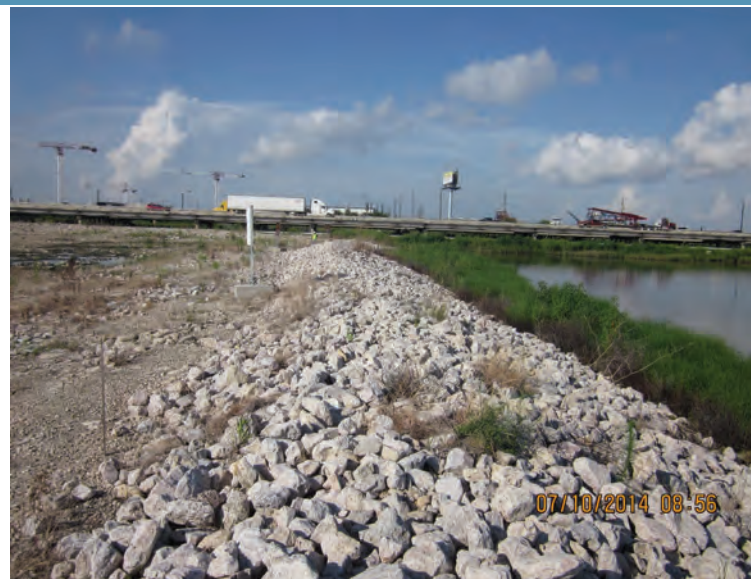
Photograph 10: Warning signs and vegetation along western berm (view south)

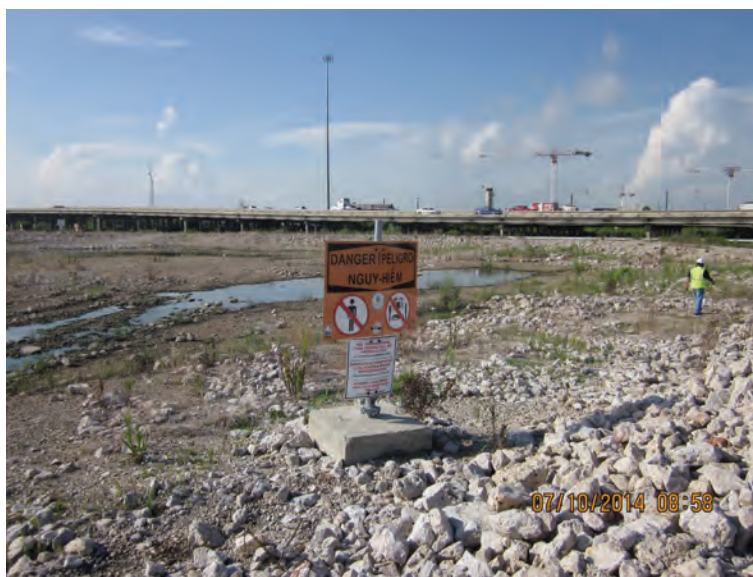
Photograph 11: Warning sign along western berm and interior of Western Cell (view southeast)

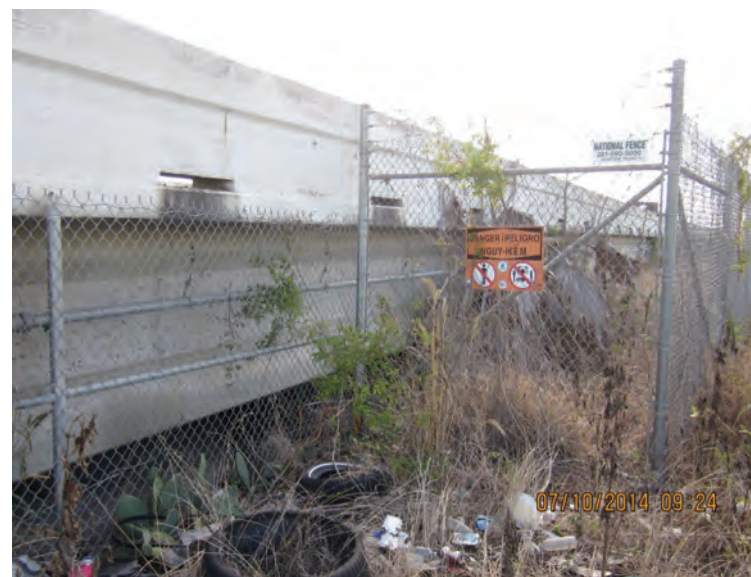
Photograph 12: Signage and perimeter fencing south of I-10 and west of San Jacinto River (view northeast)

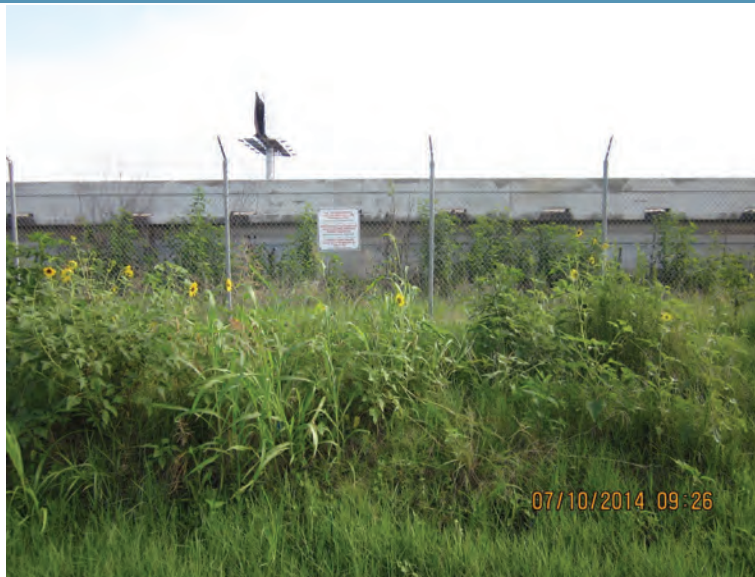
Photograph 13: Signage and perimeter fencing south of I-10 and west of San Jacinto River (view north)

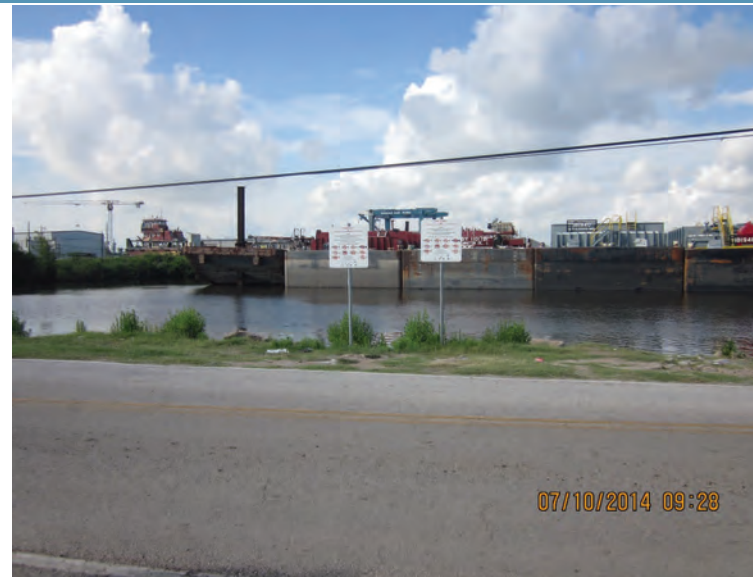
Photograph 14: Fish consumption advisory signs located south of I-10 and west of San Jacinto River (view south)

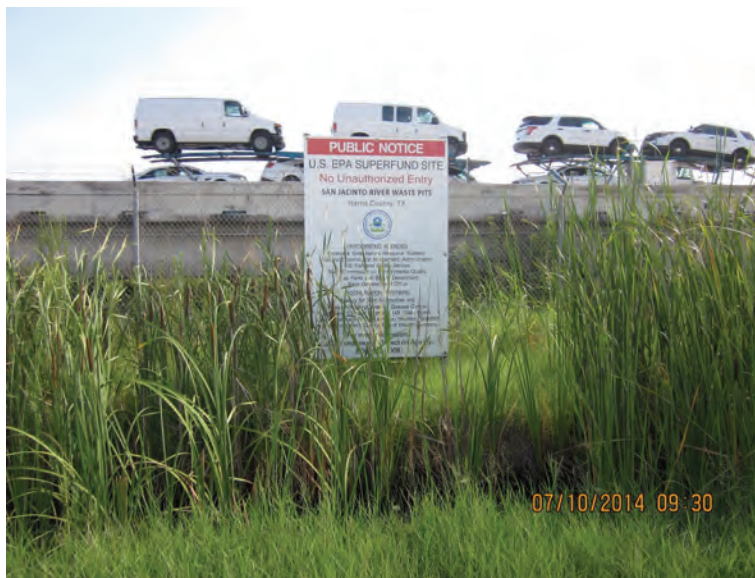
Photograph 15: USEPA public notice sign south of I-10 and west of San Jacinto River (view north)

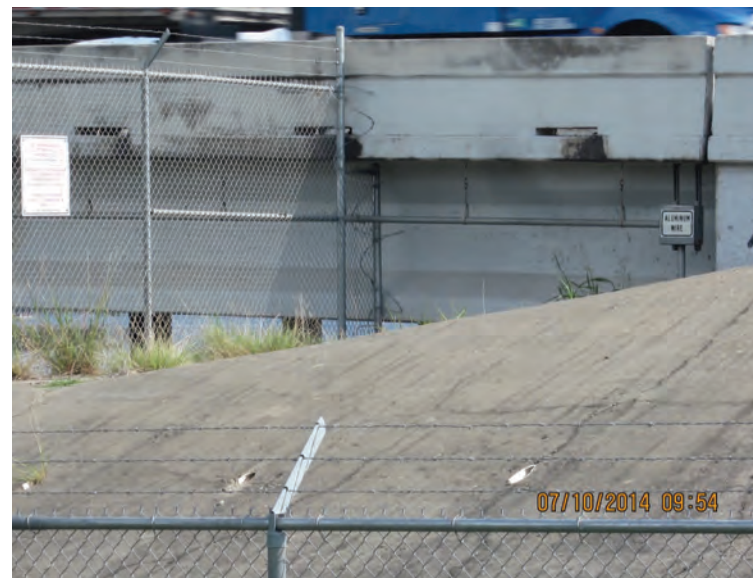
Photograph 16: Perimeter fencing south of and adjacent to I-10 and east of San Jacinto River (view northwest)
